Lake Shannon Dam
Dam Identification No. 621 | Tyrone Township, Livingston
County, Michigan

NATIONAL DAM SAFETY PROGRAM INSPECTION REPORT

October 18, 2022

September 16,2022

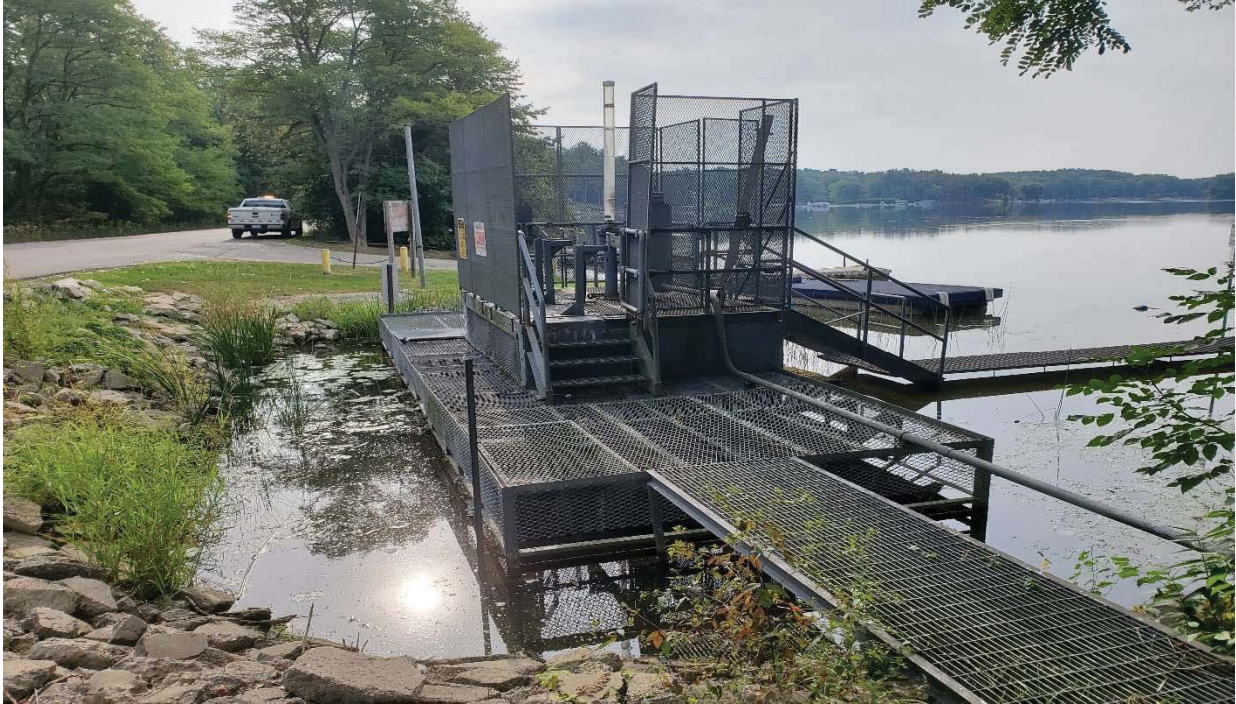
PHOTO 1

LOOKING EAST TOWARDS DAM CONTROL STRUCTURE

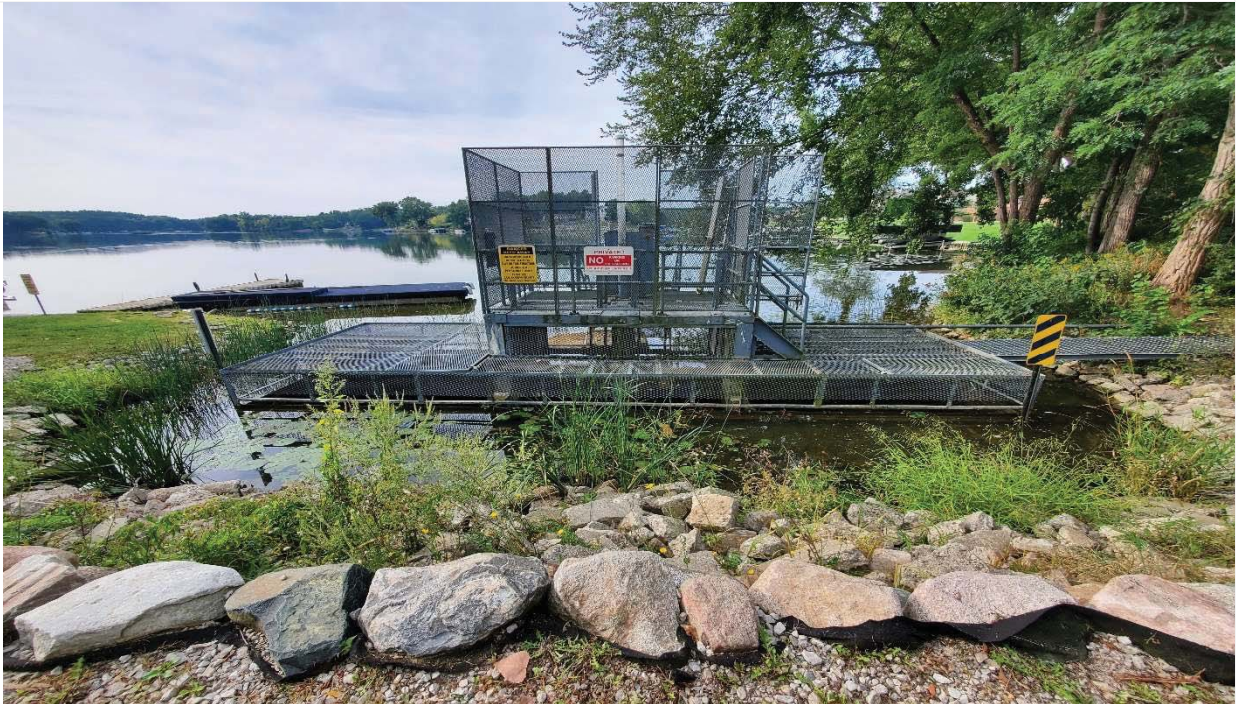
PHOTO 2

LOOKING SOUTH TOWARDS DAM CONTROL STRUCTURE

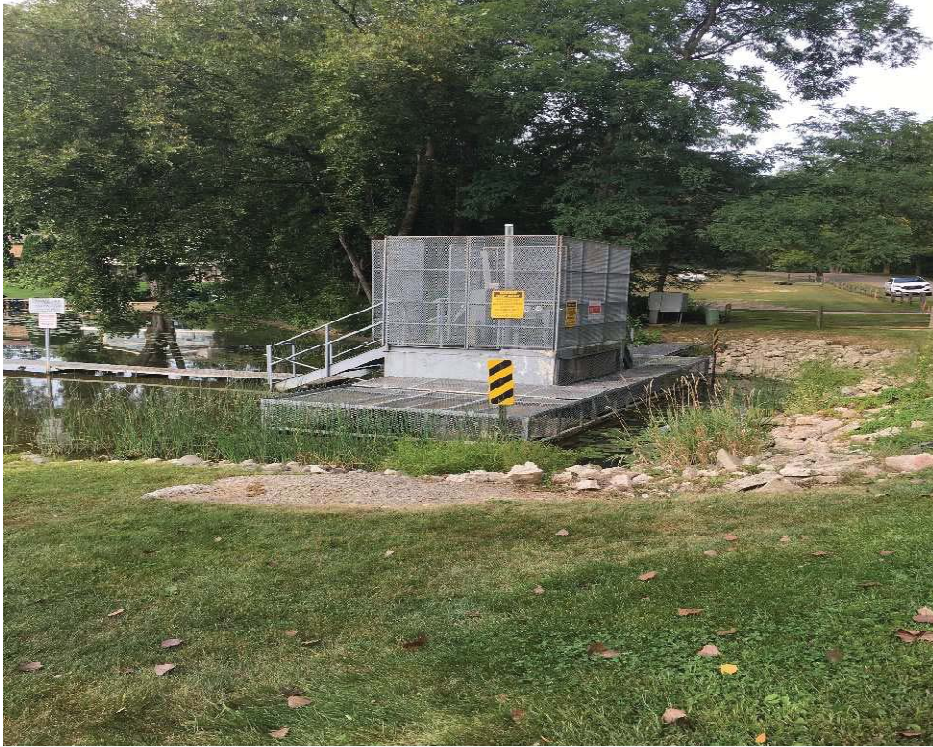
PHOTO 3

LOOKING WEST TOWARDS DAM CONTROL STRUCTURE

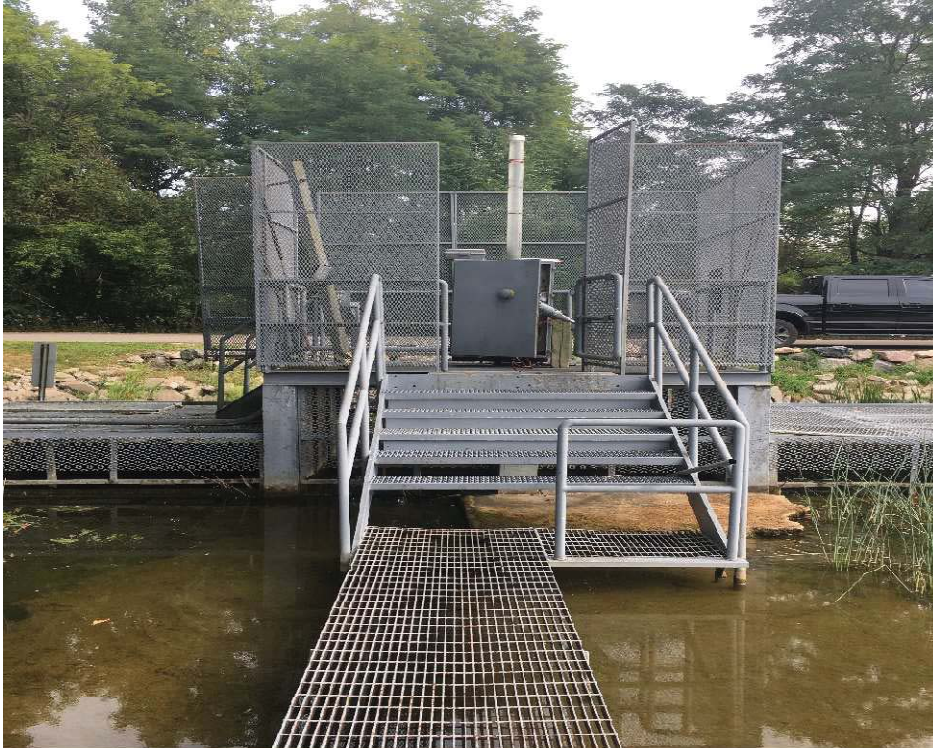
PHOTO 4

LOOKING NORTH TOWARD DAM CONTROL STRUCTURE

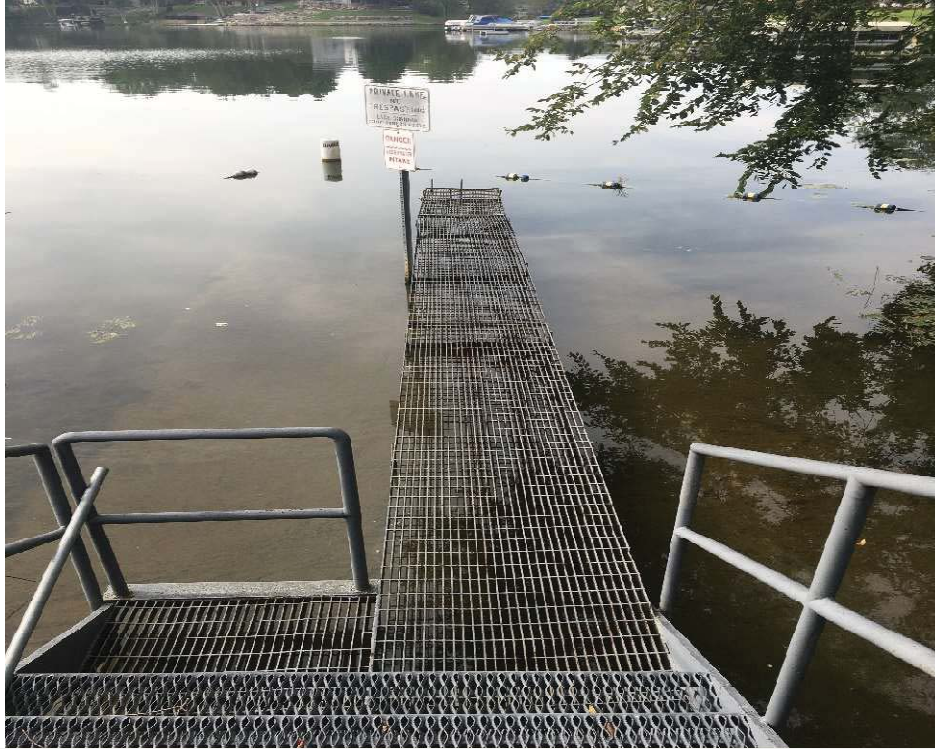
PHOTO 5

LOOKING SOUTH TOWARD LAKE FROM DAM CONTROL STRUCTURE

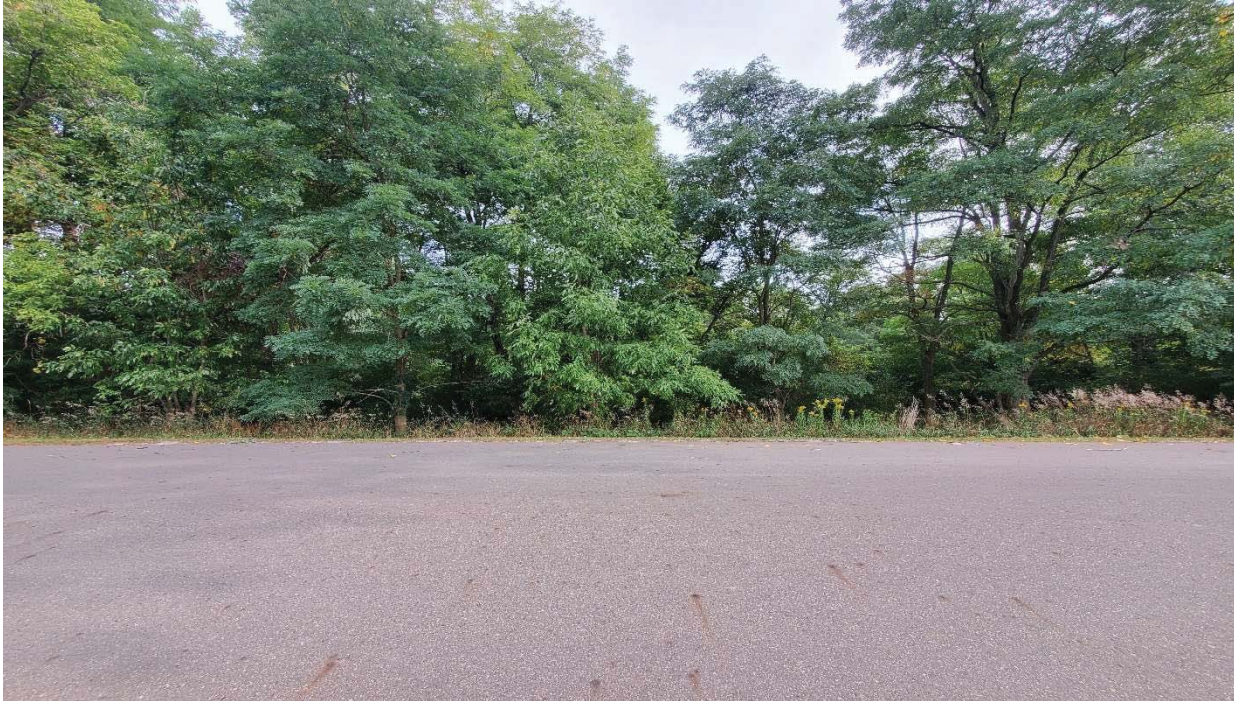
PHOTO 6

ROADWAY NORTH OF DAM CONTROL STRUCTURE LOOKING NORTH TOWARDS NORTH EMBANKMENT

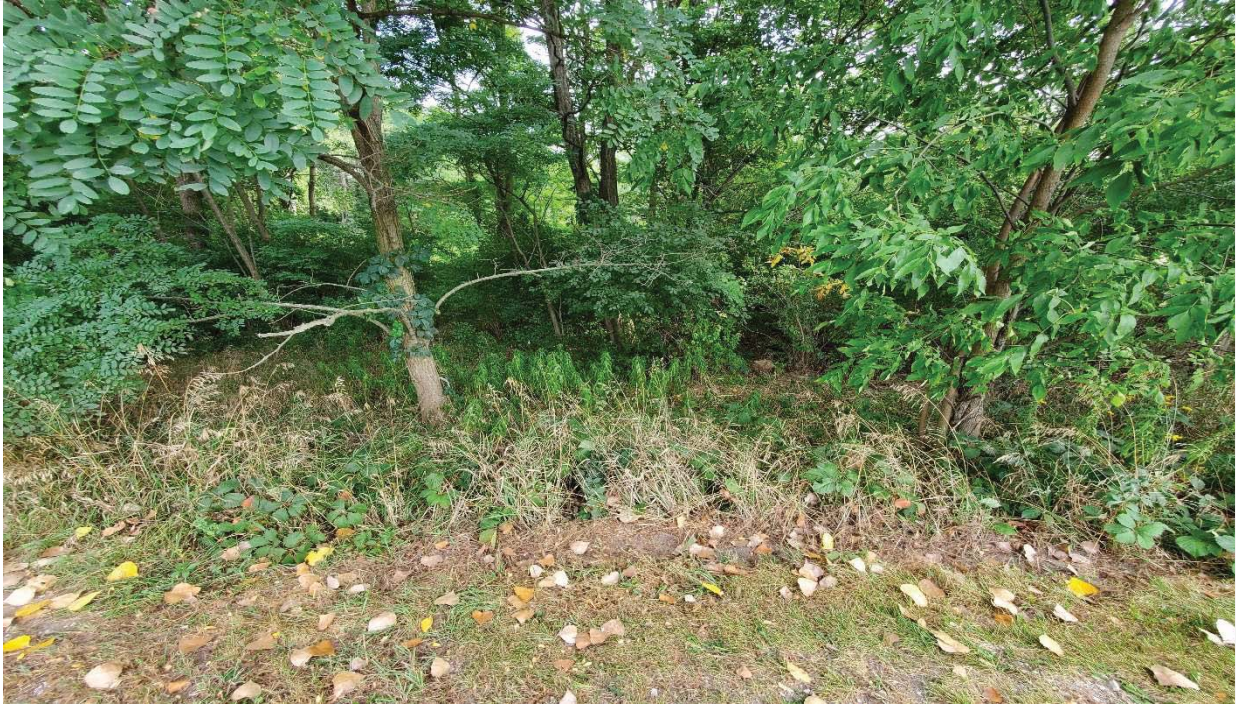
PHOTO 7

NORTH EMBANKMENT NORTH OF ROADWAY

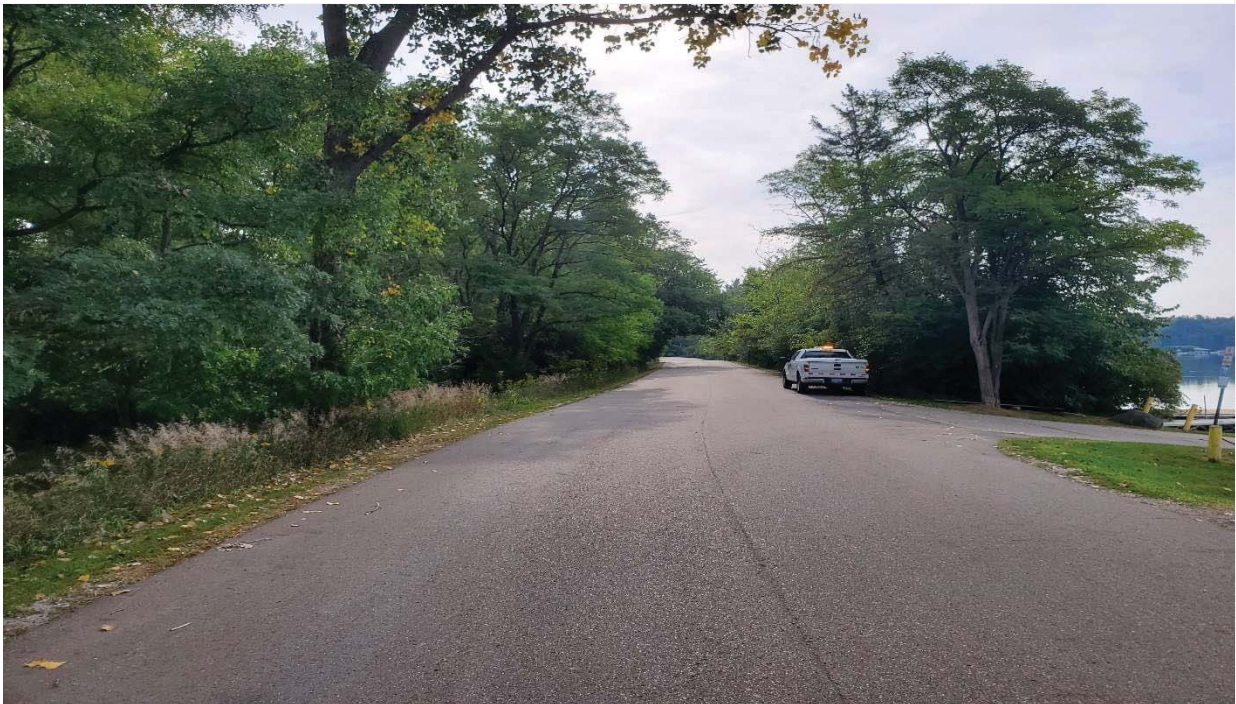
PHOTO 8

ROADWAY LOOKING EAST, NORTH OF DAM CONTROL STRUCTURE

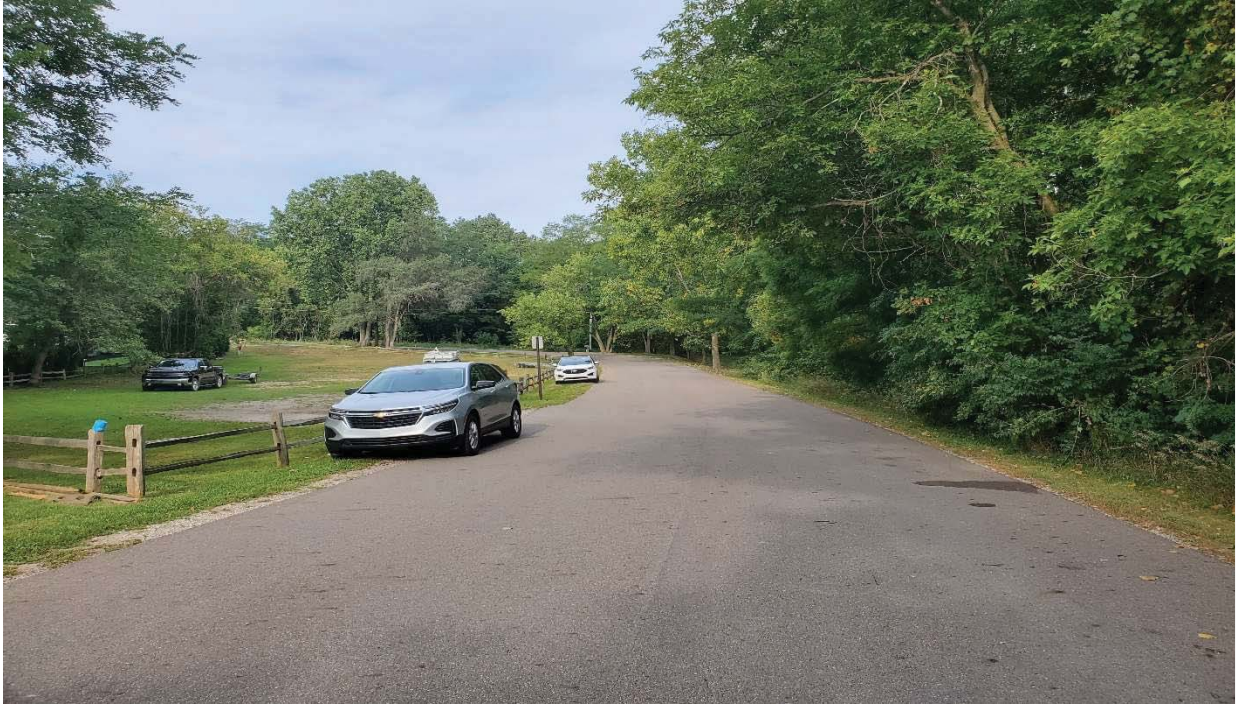
PHOTO 9

ROADWAY LOOKING WEST, NORTH OF DAM CONTROL STRUCTURE

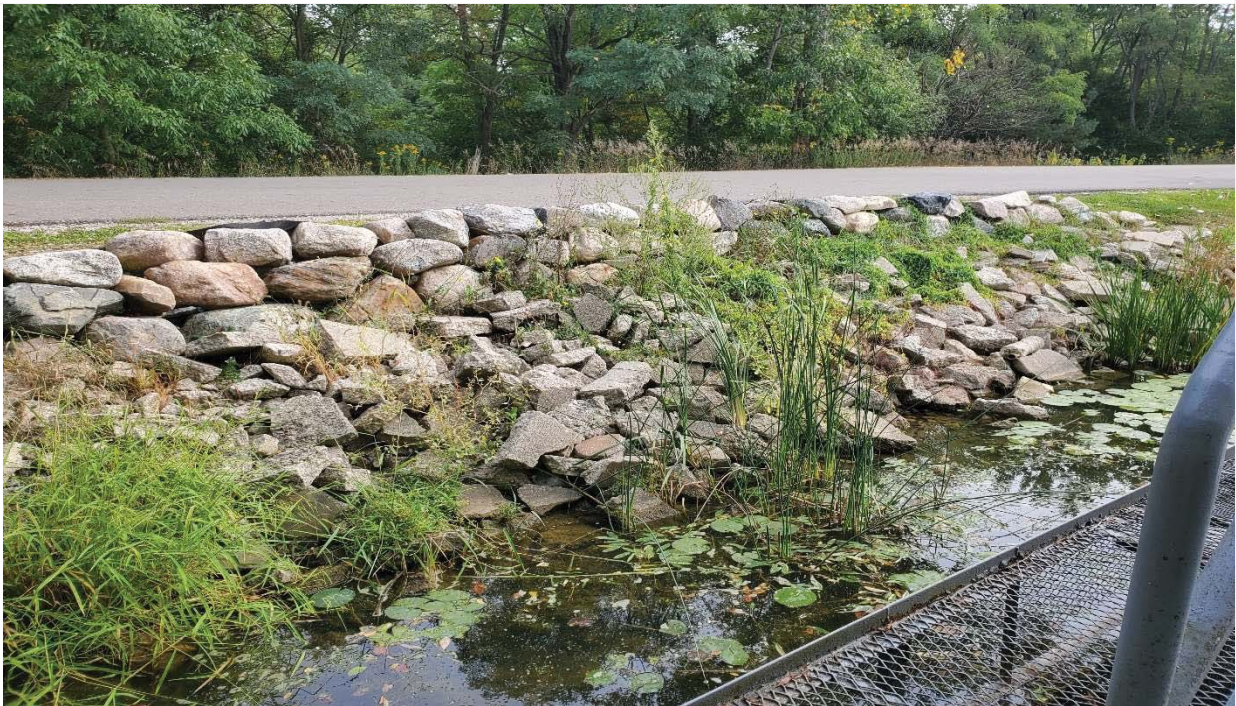
PHOTO 10

RIPRAP NORTH OF DAM CONTROL STRUCTURE, ALONG EMBANKMENT

7. Add riprap on the downstream outlet slope around the 96-inch outlet.

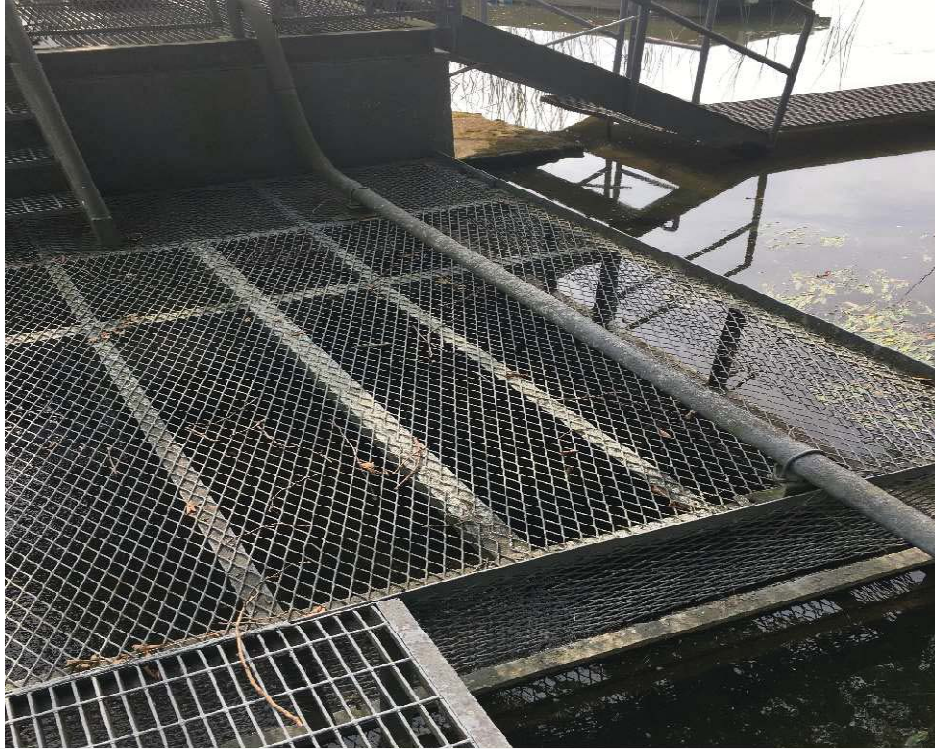
PHOTO 11

ELECTRICAL CONDUIT- ELECTRICAL BOX TO THE DAM CONTROL STRUCTURE

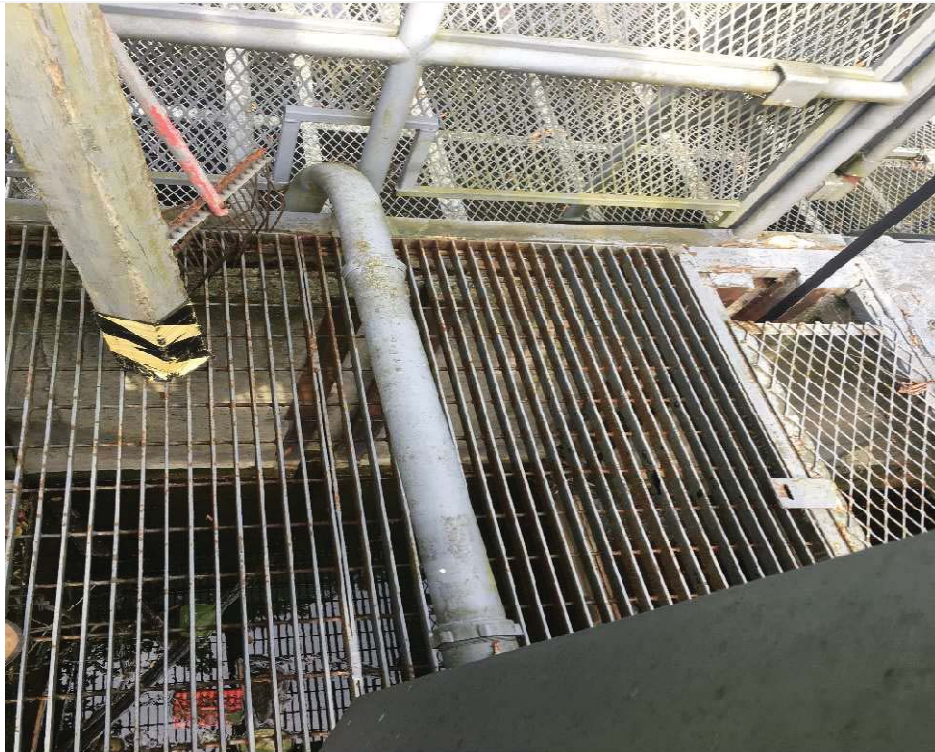
PHOTO 12

The concrete portion of the control structure that was visible during the inspection is in good condition. The exposed portion of the concrete structure is exhibiting some very minor cracking in isolated areas of concrete. There is no handrail around the lower portion of the structure. There is a walkway grating supported by the concrete walls. The grating does not feel adequate as it deflects when walking across it. There are two areas where there are hinged floor openings that stick up above the adjacent walk surface. These present significant trip hazards. In addition, at the west side of the lower walkway, a 3-inch electrical conduit is approximately six inches above the walkway presenting yet another significant trip hazard.

CLOSE UP OF ELECTRICAL CONDUIT AS TRIP HAZARD

5. There are a number of trip hazards presenting themselves on the grating walkway that need to be eliminated.
6. Add rip rap to the upstream embankment shoreline from edge of water, up the embankment.

From an operational standpoint, the center sluice gate is a motor operated vertical lift gate. This is operated manually (with any automatic controls) by way of a Rigid 700 power drive that is fed from an extension cord inside the control box on the structure. The power drive, which is removable, attaches to a square nut drive that in turn, raises and lowers the sluice gate located at the 60-inch inlet pipe. During the inspection, the power drive was engaged and raised and lowered the sluice gate an inch or so. This was to show the gate and motor drive operated. The two stop logs are manually operated. Each is raised or lowered via a dual hand crank with heavy duty nylon straps. The stop logs were not exercised during the inspection. However, it was noted that new nylon straps and new ratcheted manual lifts have replaced older lift equipment. It is the opinion of this inspector that repairs be made to the steel walkway grating to eliminate the trip hazards at the grating. Also, either the steel conduit be relocated to eliminate the trip hazard, or a level of grating be installed above it to create an intermediate landing.

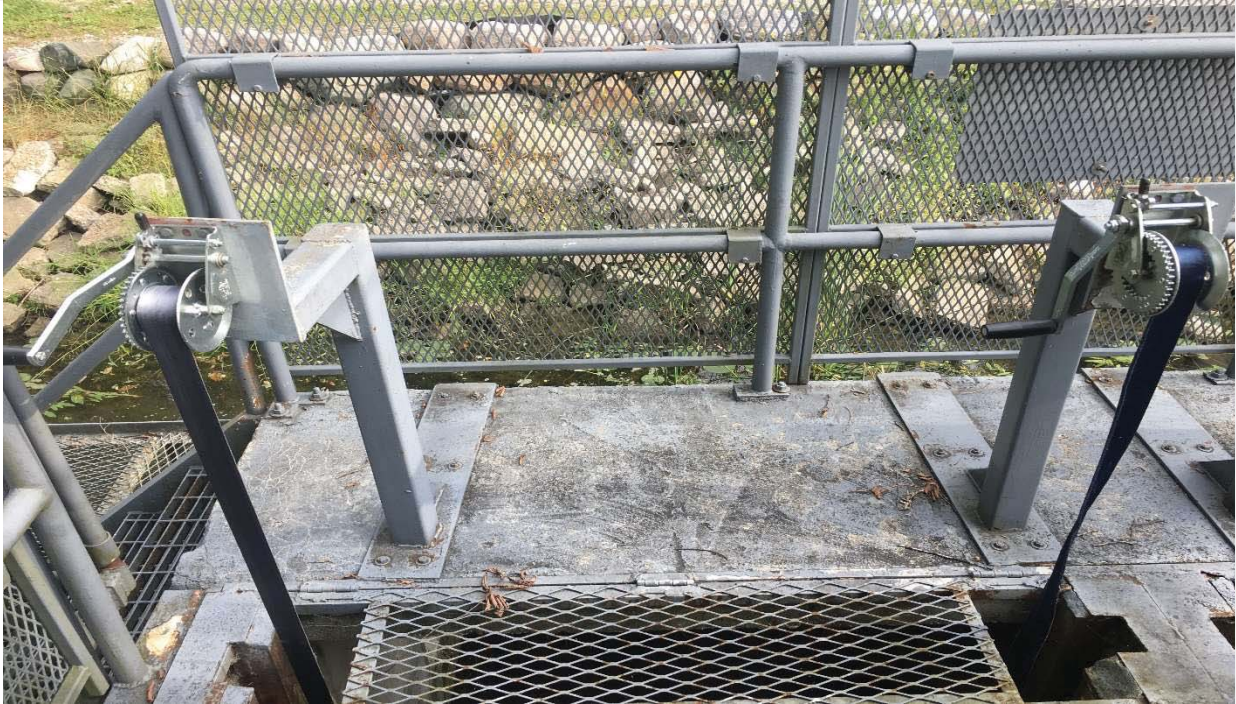
PHOTO 13

TYPICAL PULLEY SYSTEM TO OPEN STOP LOGS (TYP 2 LOCATIONS)

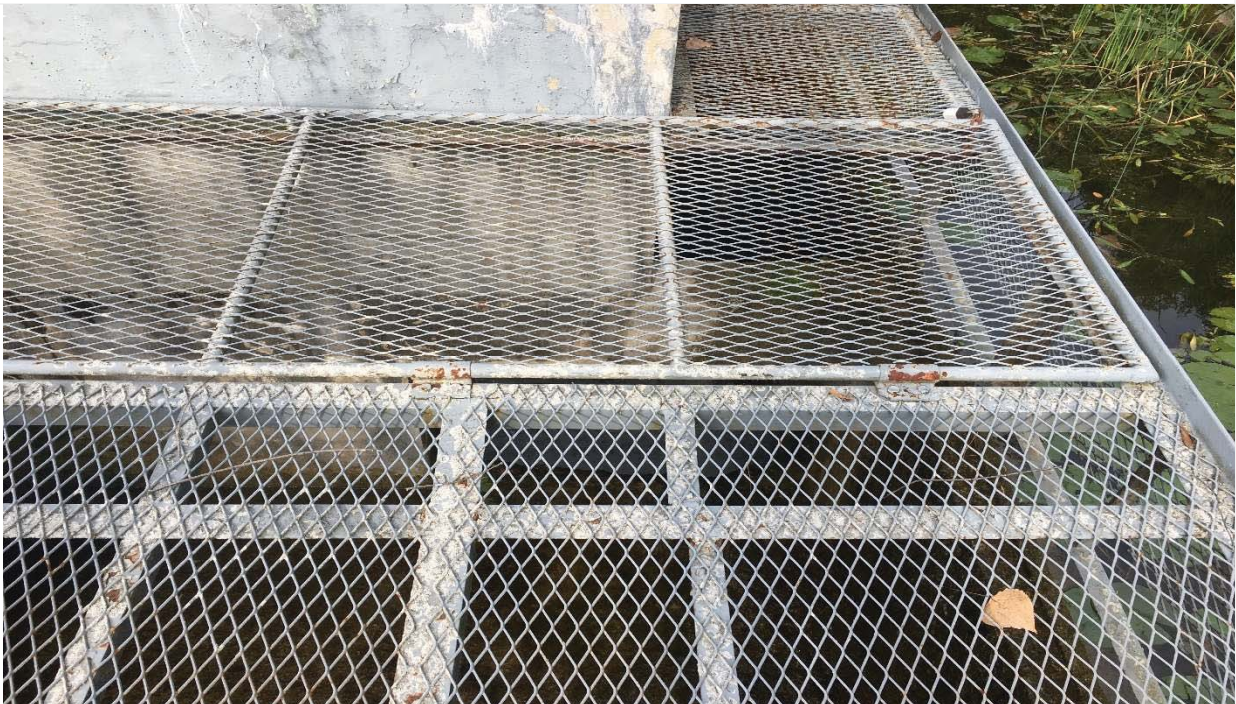
PHOTO 14

TRIP HAZARD ON DAM CONTROL STRUCTURE

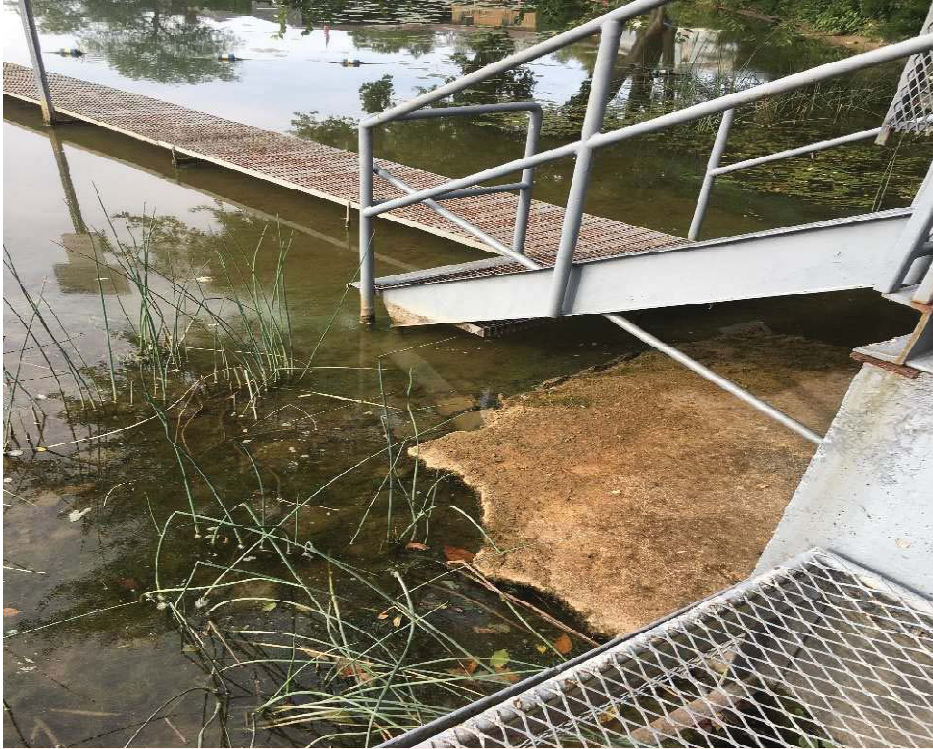
PHOTO 15

SEDIMENT BUILDUP, SOUTH SIDE OF DAM CONTROL STRUCTURE

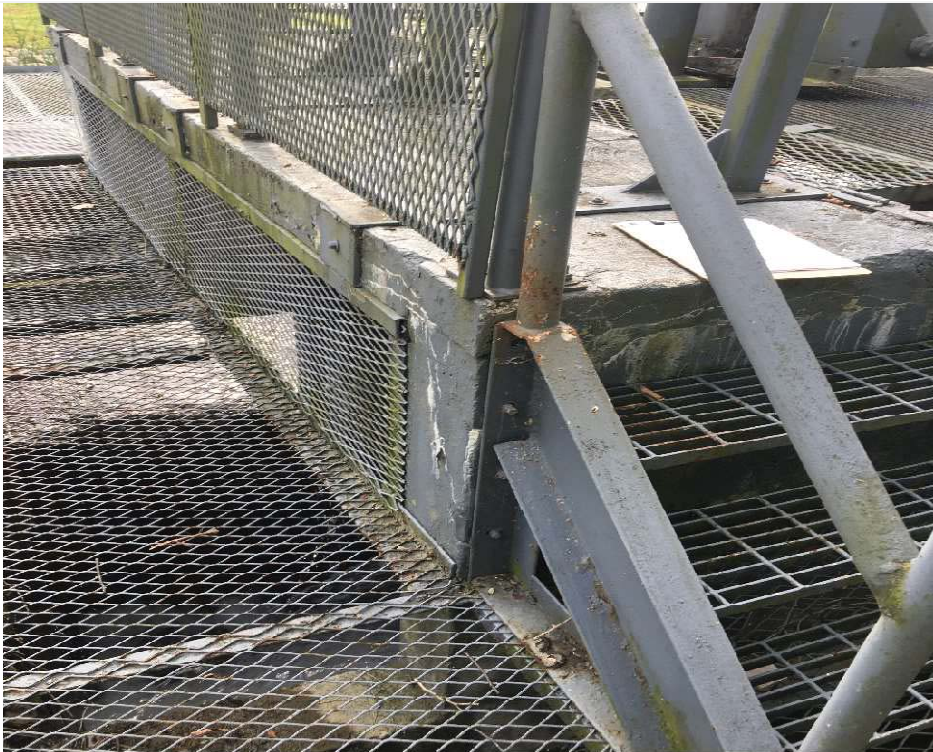
PHOTO 16

RUSTING & DETERIORATION ON STEEL SURFACES OF DAM CONTROL STRUCTURE

The general overall condition of the dam appears to be in generally good condition. There is no visual evidence of any structural instability of the dam. The gate structure requires some rehabilitation and possibly painting to maintain the structure and make it a safe environment for walking on. Overall, the embankment itself is in good condition. As noted, the downstream spillway needs to be cleaned of debris and a method employed to keep illegal dumping out of the spillway.

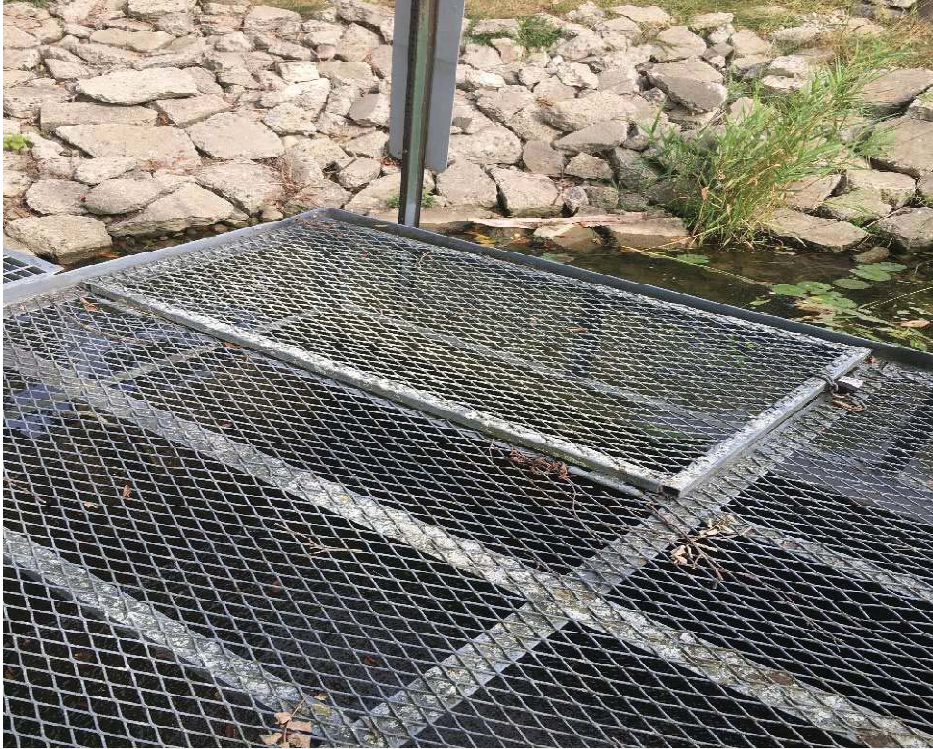
PHOTO 17

TRIP HAZARD ON DAM CONTROL STRUCTURE

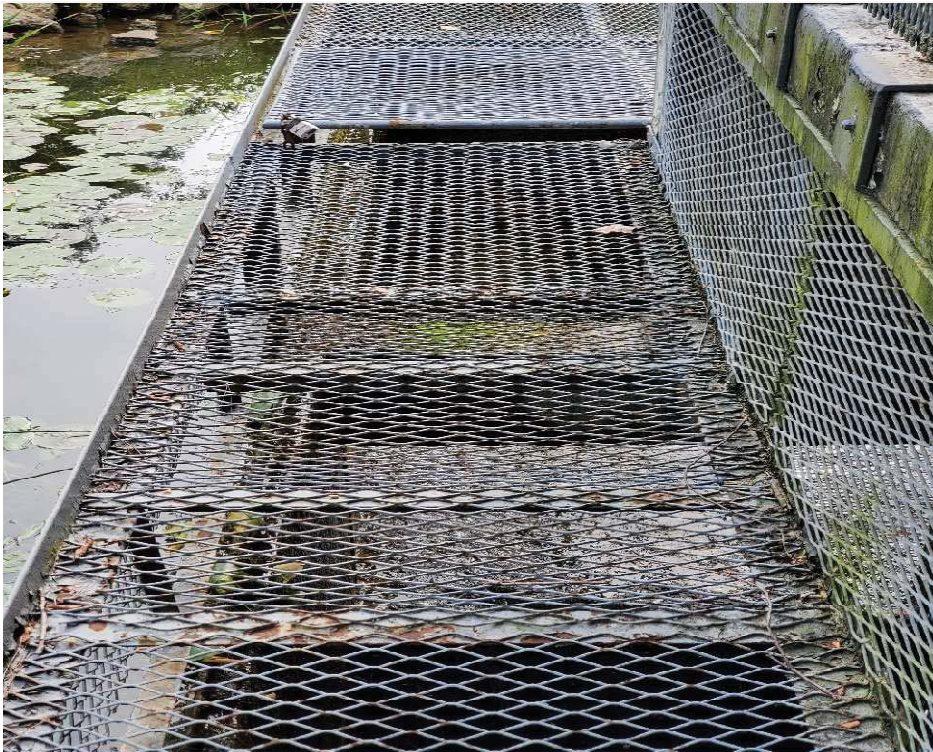
PHOTO 18

TYPICAL GRATING AND SUPPORT SYSTEM @ CONTROL STRUCTURE

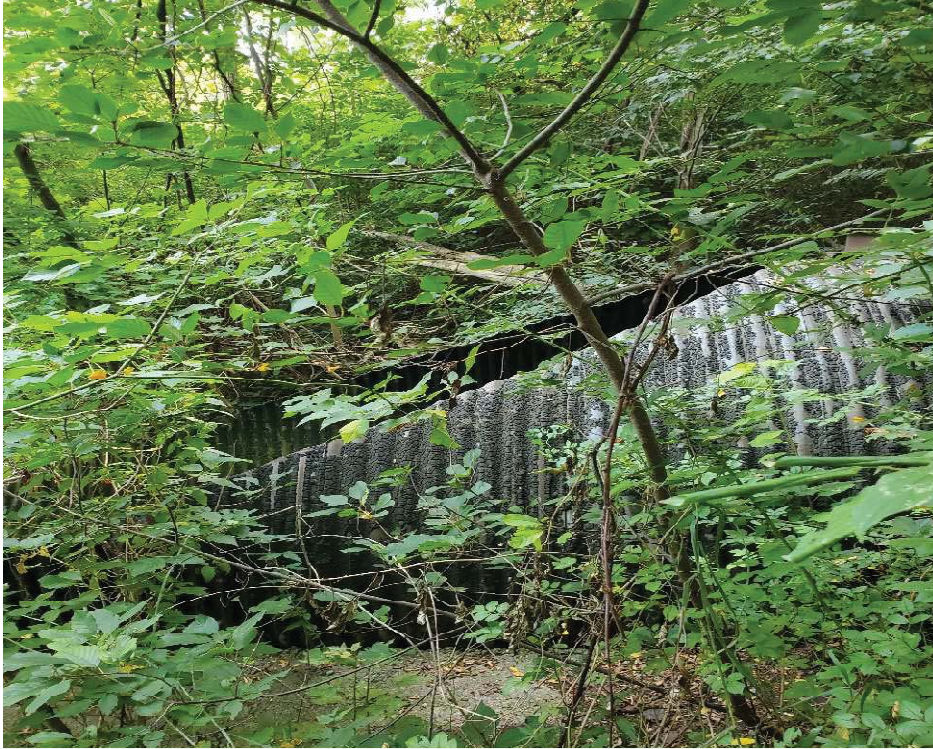
PHOTO 19

The 96-inch corrugated multi-plate (CMP) culvert that serves to convey downstream flow through the embankment is in relatively good condition. There is some minor rusting of the metal plates but does not appear to have threatened the integrity of the pipe. There are steel sheet piling wingwalls either side of the pipe that retain the slopes in behind the walls around the pipe. There is no indication of movement of these walls. There is some riprap in place at the invert outlet of the pipe. Outlet flow under normal flow is in general alignment with the downstream North Ore Creek.

DOWNSTREAM CORRUGATED METAL PIPE OUTFLOW DISCHARGE

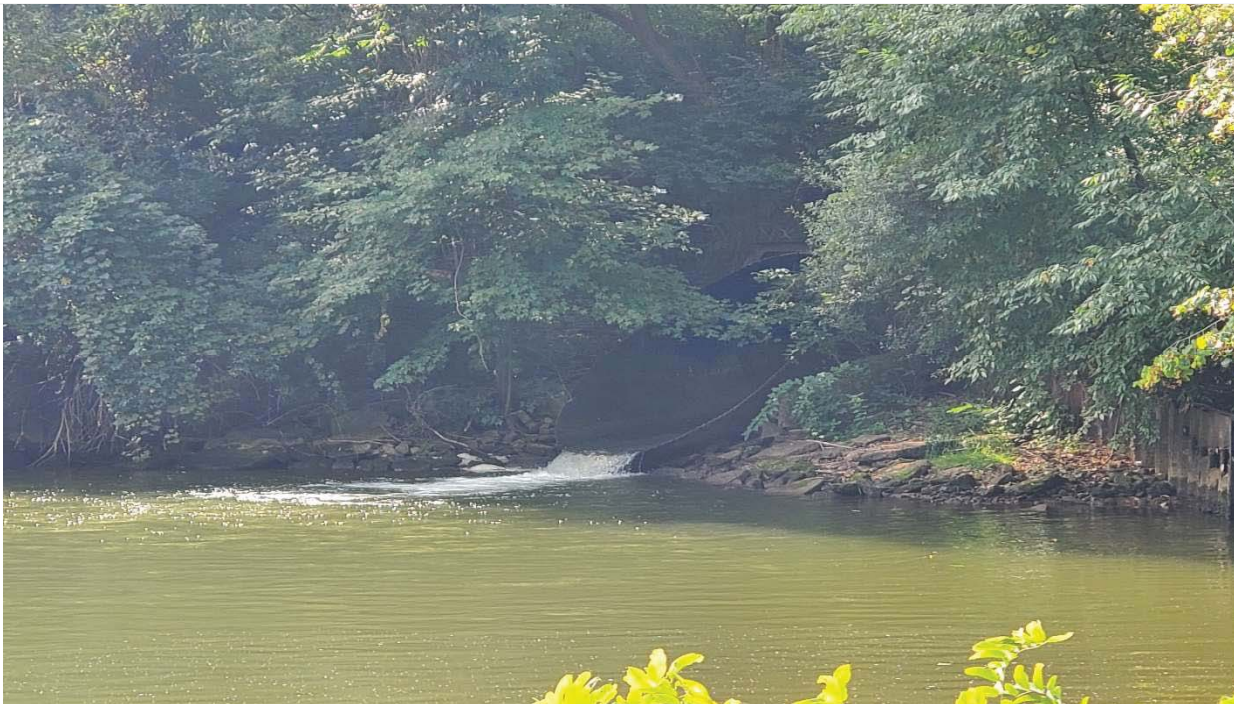
PHOTO 20

DOWNSTREAM LOOKING SOUTH TOWARD 96 IN CORRUGATED METAL PIPE DISCHARGE INTO NORTH ORE CREEK

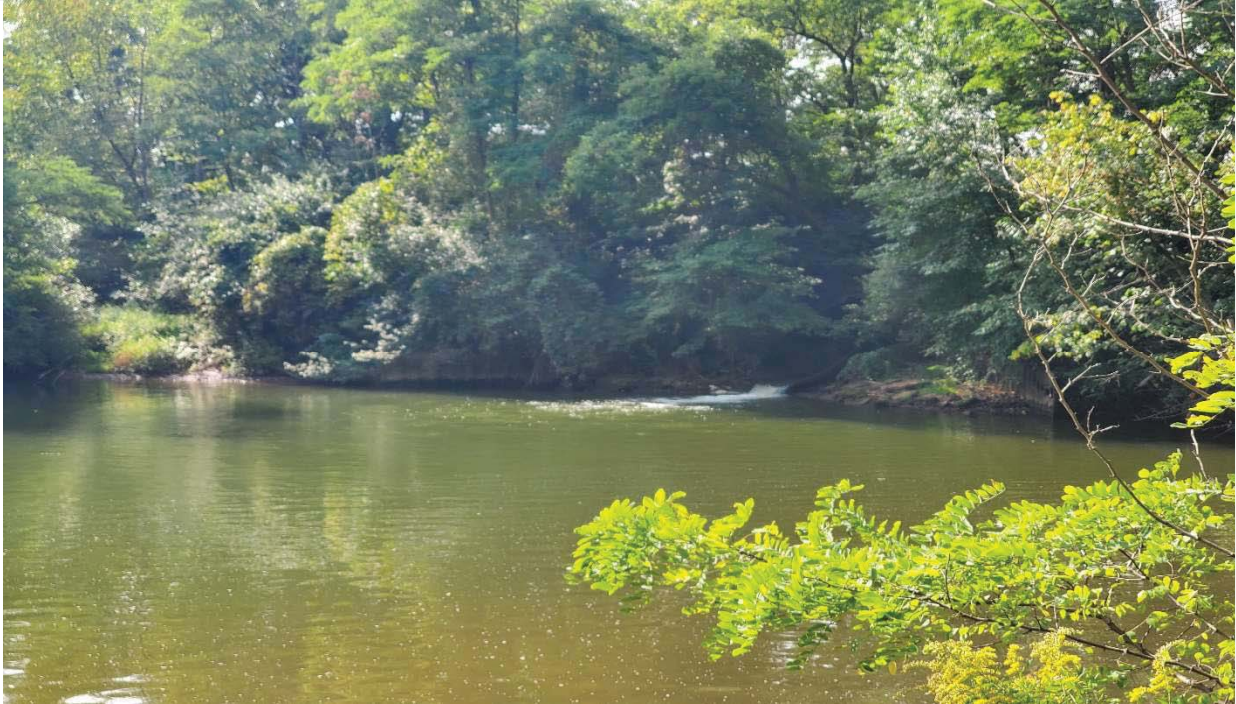
PHOTO 21

DOWNSTREAM OUTFLOW RIVER AREA LOOKING SOUTH

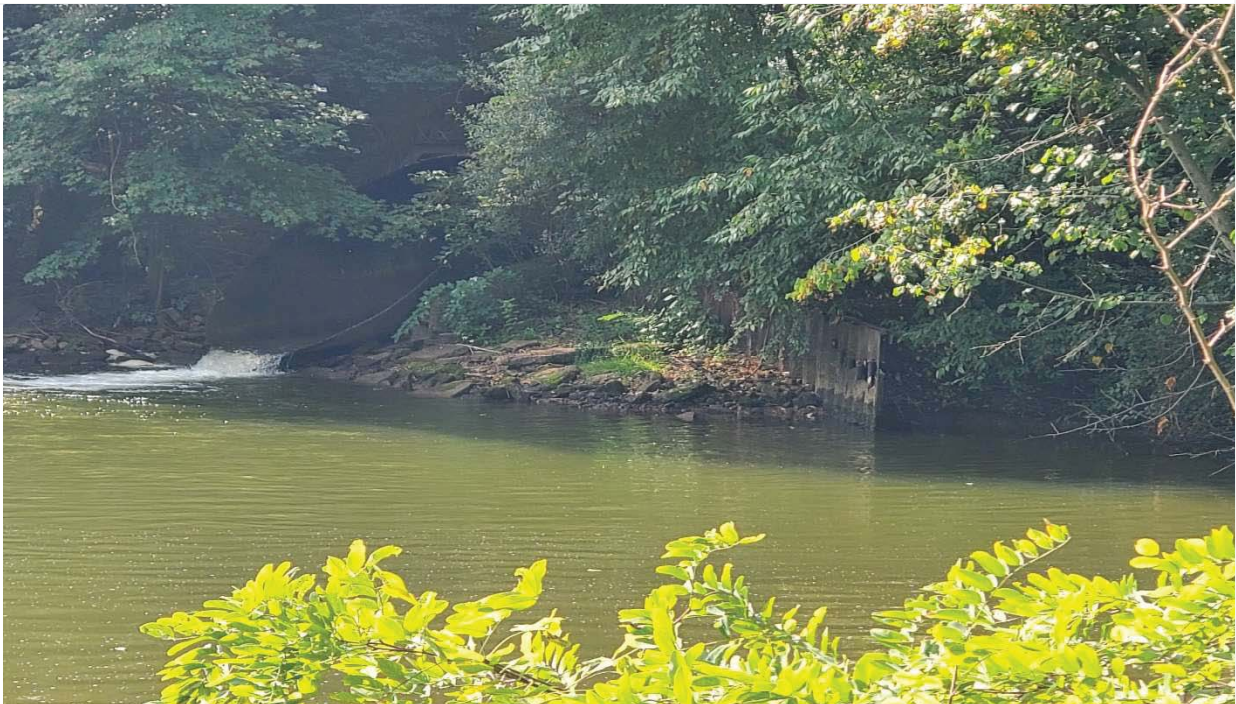
PHOTO 22

SHEET PILING TO WEST OF OUTFLOW DISCHARGE PIPE

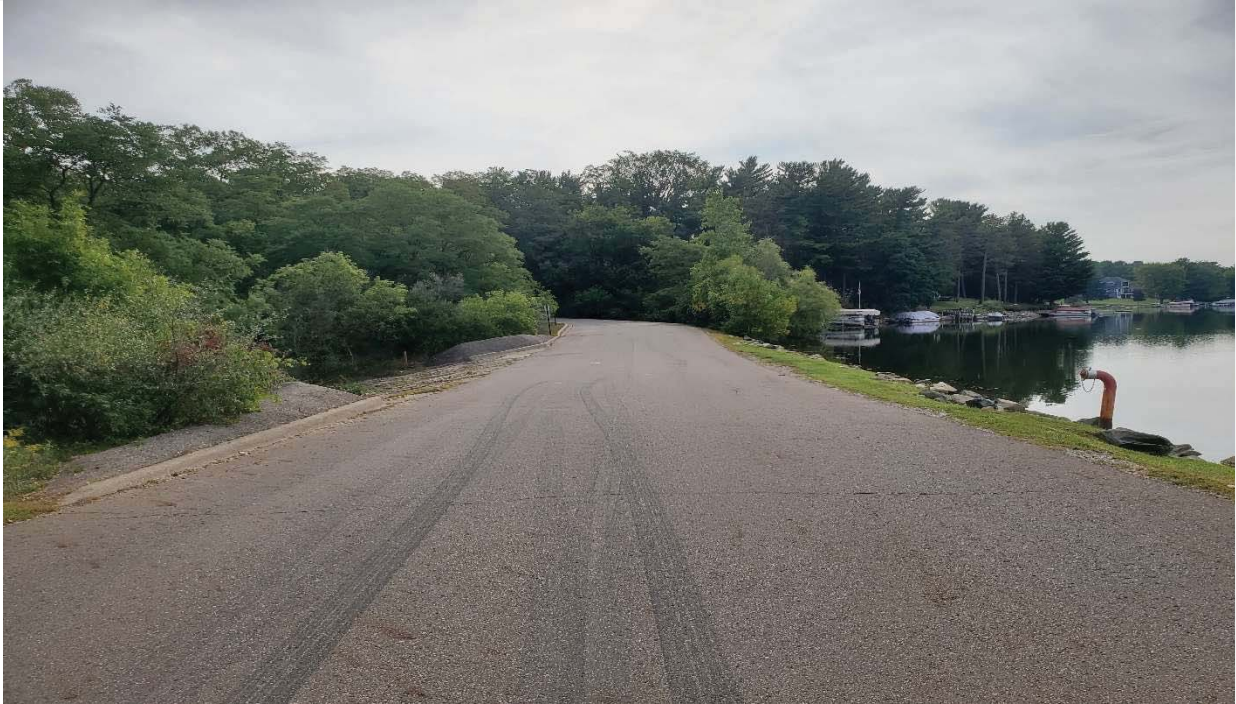
PHOTO 23

EMERGENCY SPILLWAY LOOKING EAST

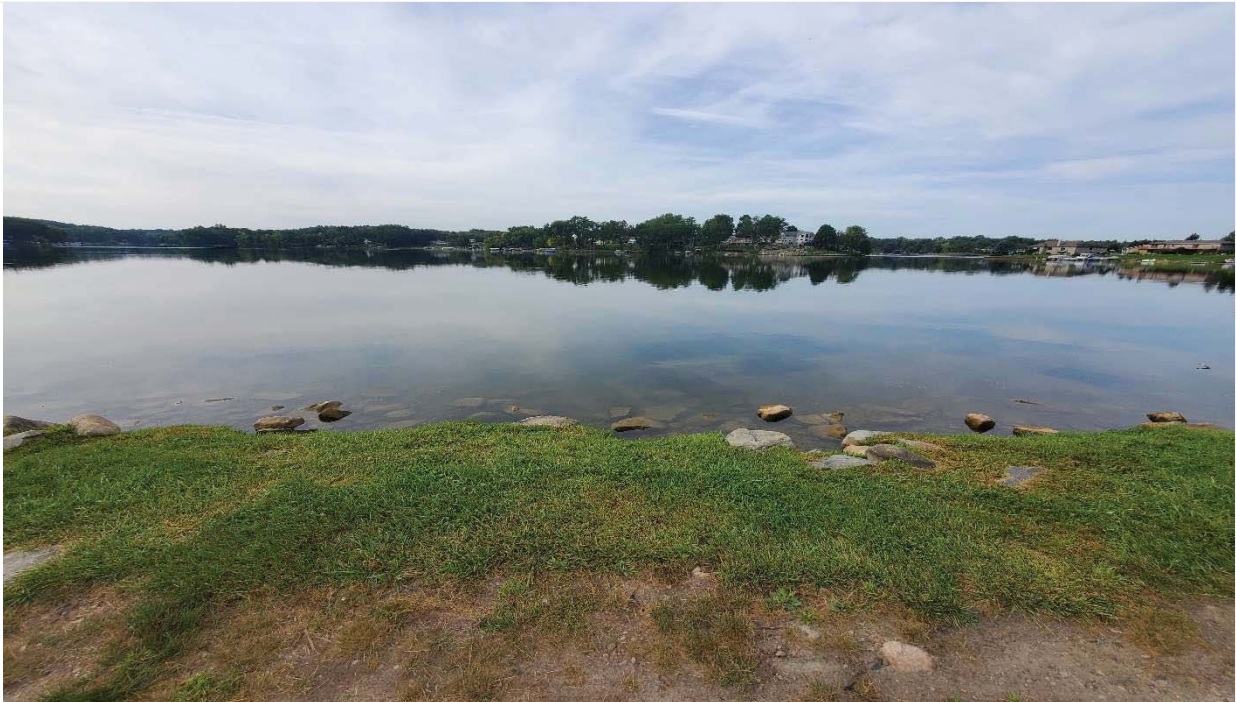
PHOTO 24

SOUTH EMBANKMENT OF EMERGENCY SPILLWAY LOOKING SOUTH TOWARD LAKE

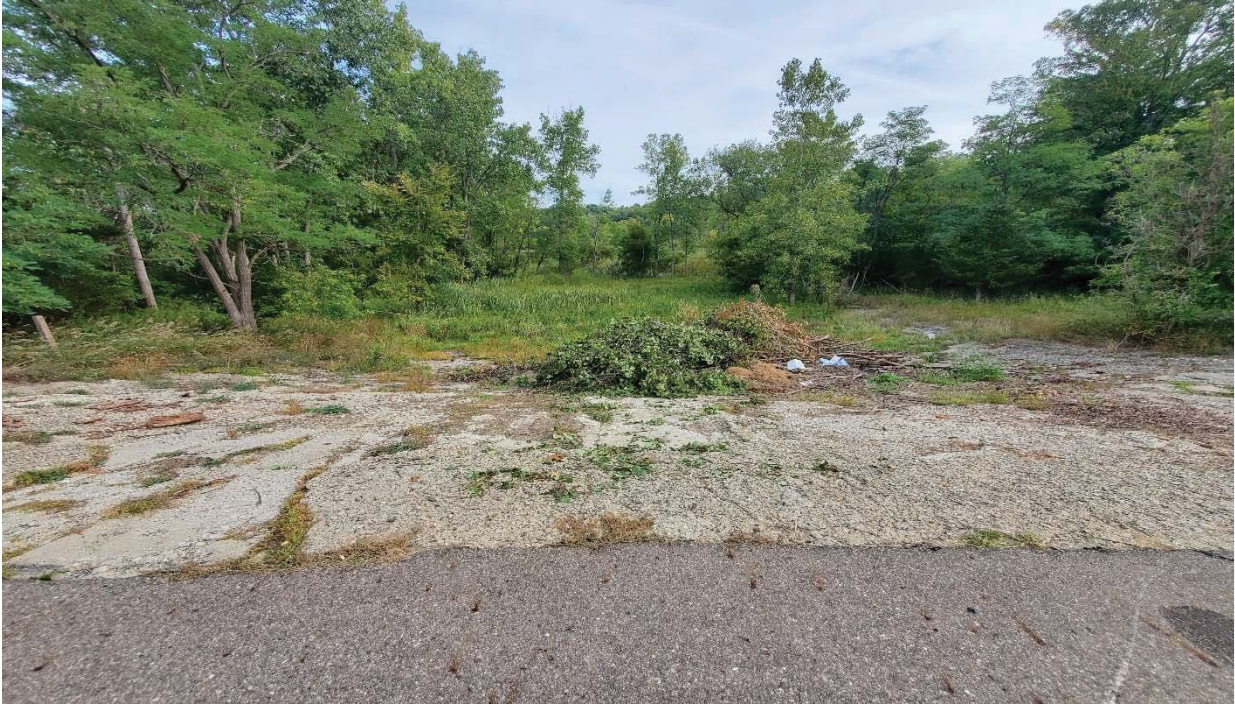
PHOTO 25

NORTH EMBANKMENT OF EMERGENCY SPILLWAY LOOKING NORTH, DEBRIS PILE BUILDUP IN MIDDLE OF CONCRETE SLOPING SURFACES

4. Debris pile should be removed from auxiliary spillway on downstream side. A guardrail with gate should be placed along the length of the spillway to prevent access into the spillway resulting in the illegal dumping.

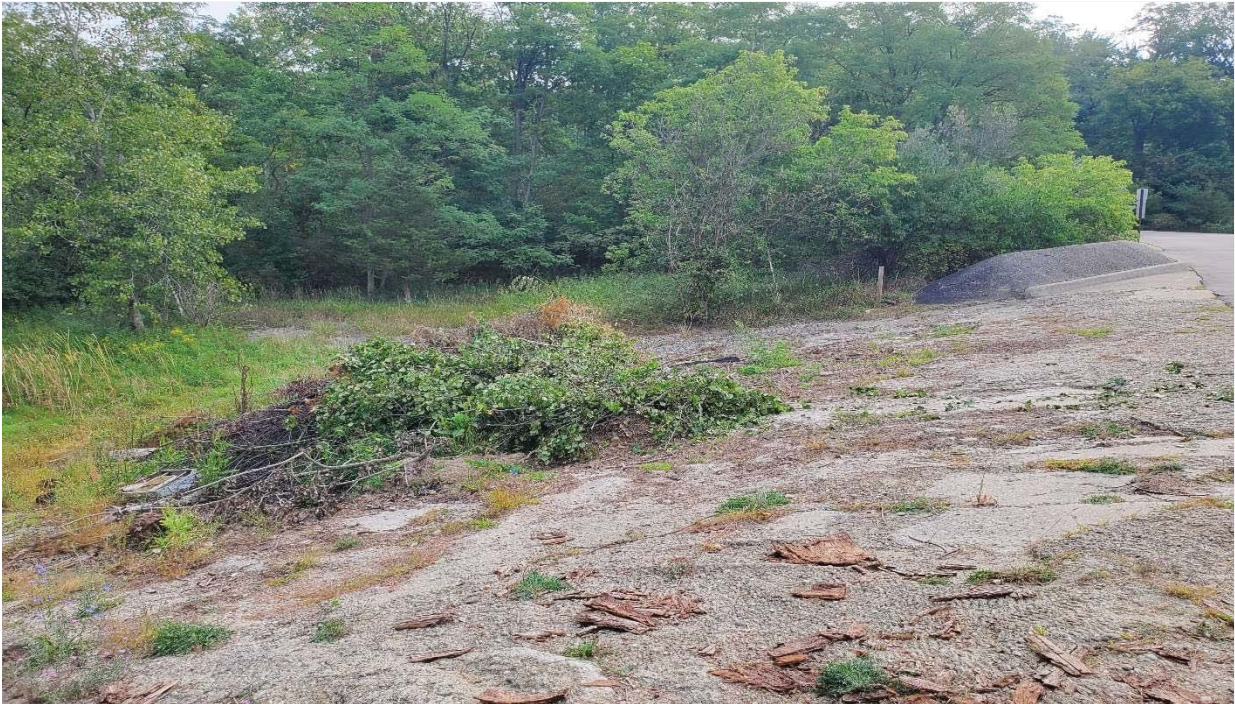
PHOTO 26

NORTH EMBANKMENT OF EMERGENCY SPILLWAY LOOKING EAST, DEBRIS PILE IN MIDDLE OF CONCRETE SLOPING SURFACES

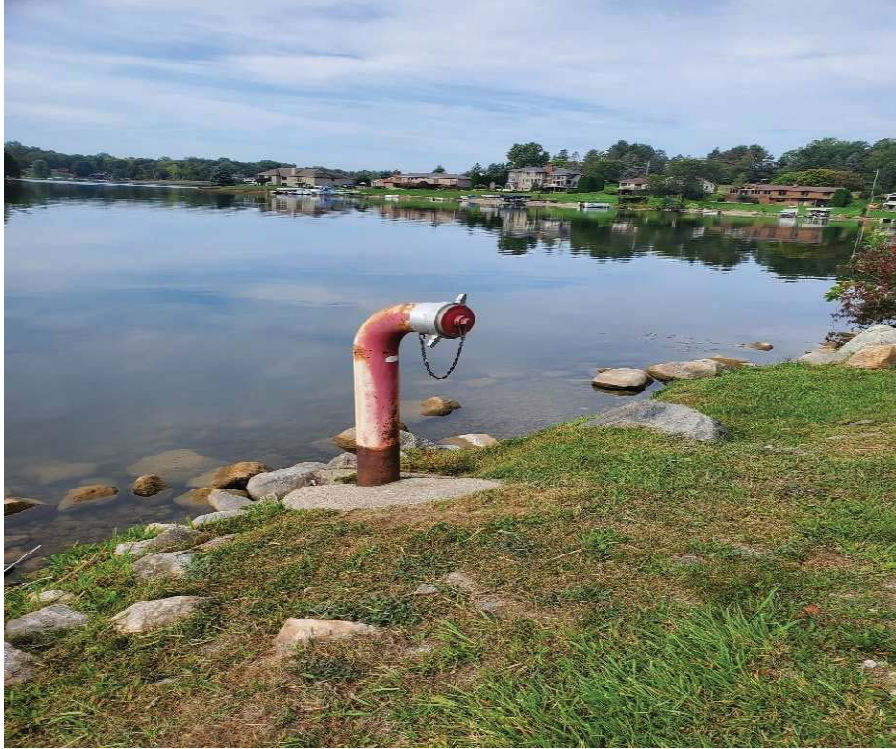
PHOTO 27

EMERGENCY DRY HYDRANT VALVE
