Lake Shannon Dam
Dam Identification No. 621 | Tyrone Township, Livingston
County, Michigan

NATIONAL DAM SAFETY PROGRAM INSPECTION REPORT

October 18, 2022

September 16,2022

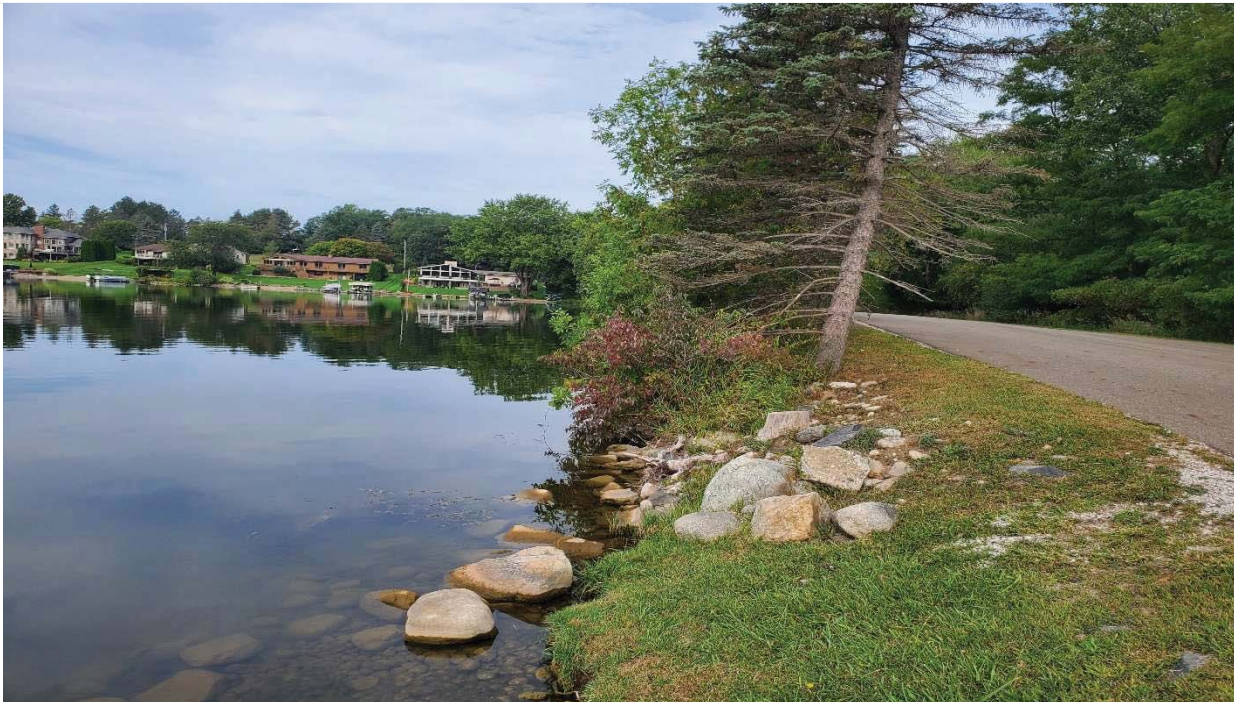
PHOTO 28

TYPICAL SOUTH EMBANKMENT OF LAKE SHANNON NEAR EMERGENCY SPILLWAY

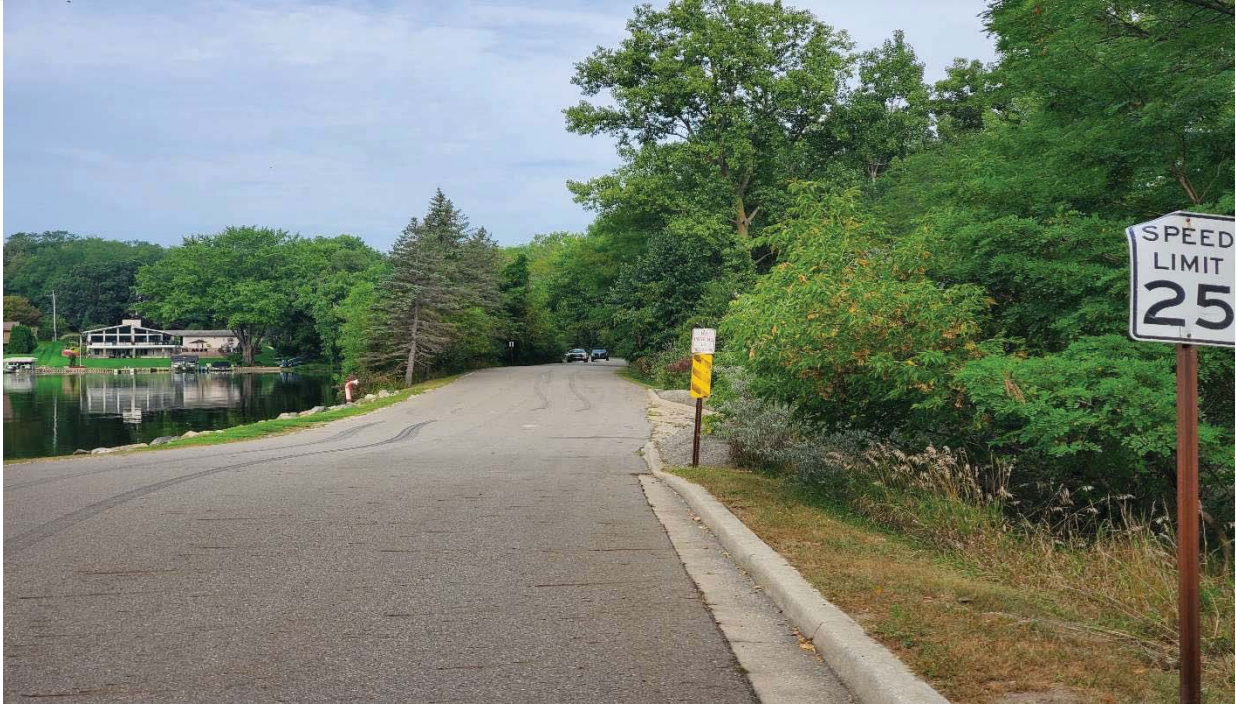
PHOTO 29

EMERGENCY SPILLWAY LOOKING WEST

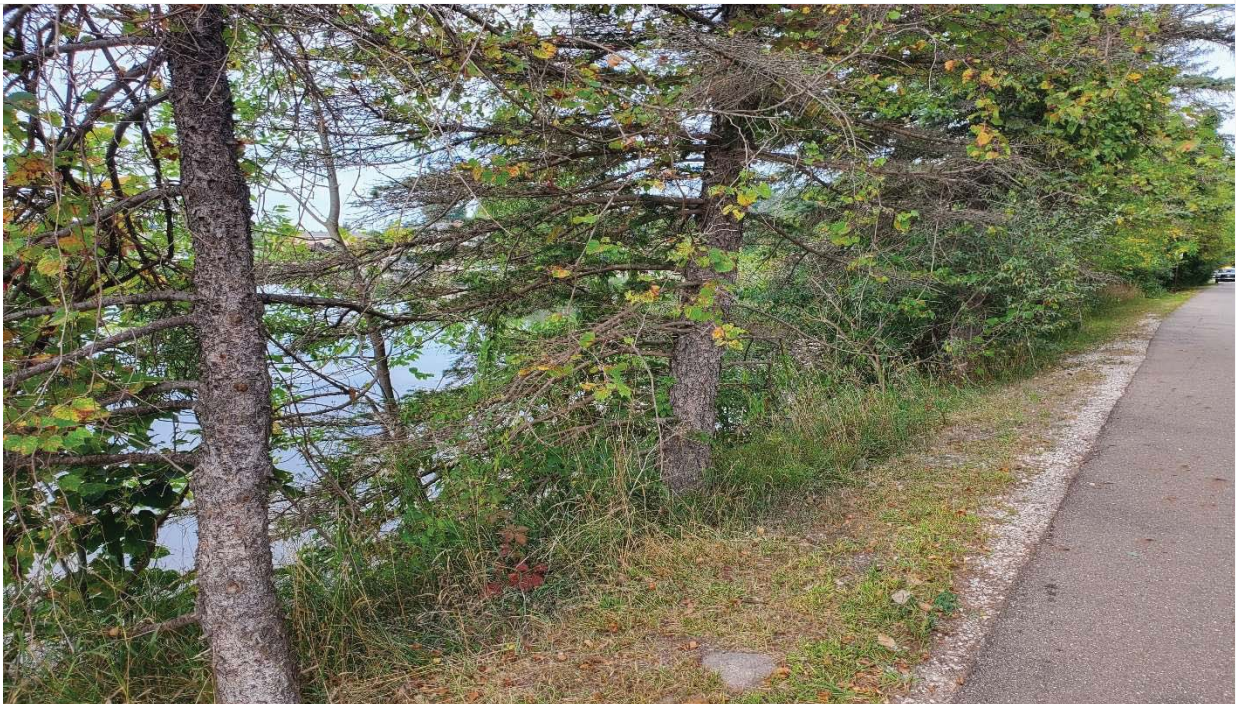
PHOTO 30

The embankment is heavily vegetated with extreme overgrowth and extensive tall trees along each side of the embankment. What could be examined along the length of the embankment revealed no evidence of seepage or sloughing/settlement of soils due to seepage through the soils. No animal burrows were detected, although the areas of heavy overgrowth could not be examined extensively. The upstream shoreline along Lake Shannon could use additional rip rap to protect against wave action on the lake. Along the centerline of the embankment is Driftwood Drive. It is a 24-foot-wide asphalt paved road with two-foot gravel shoulders each side. As it traverses north to south along the embankment, it changes elevation to account for the emergency spillway across the road/embankment. The HMA surface is in good condition. There is no cracking of the asphalt surface which could indicate settlement or movement of the roadway and embankment.

TYPICAL TREE AND BRUSH GROWTH BUILDUP ON THE SOUTH EMBANKMENT

1. Safety handrail should be attached to the perimeter of the control structure to prevent people from falling off the structure and into the water.
2. Trees should be removed from the upstream and downstream sides of the embankment. Strong winds could uproot the trees, causing damage to the

integrity of the embankment and potential failure to the embankment. Grass and lower lying overgrowth would be acceptable to maintain soil stability to the embankment and erosion protection.

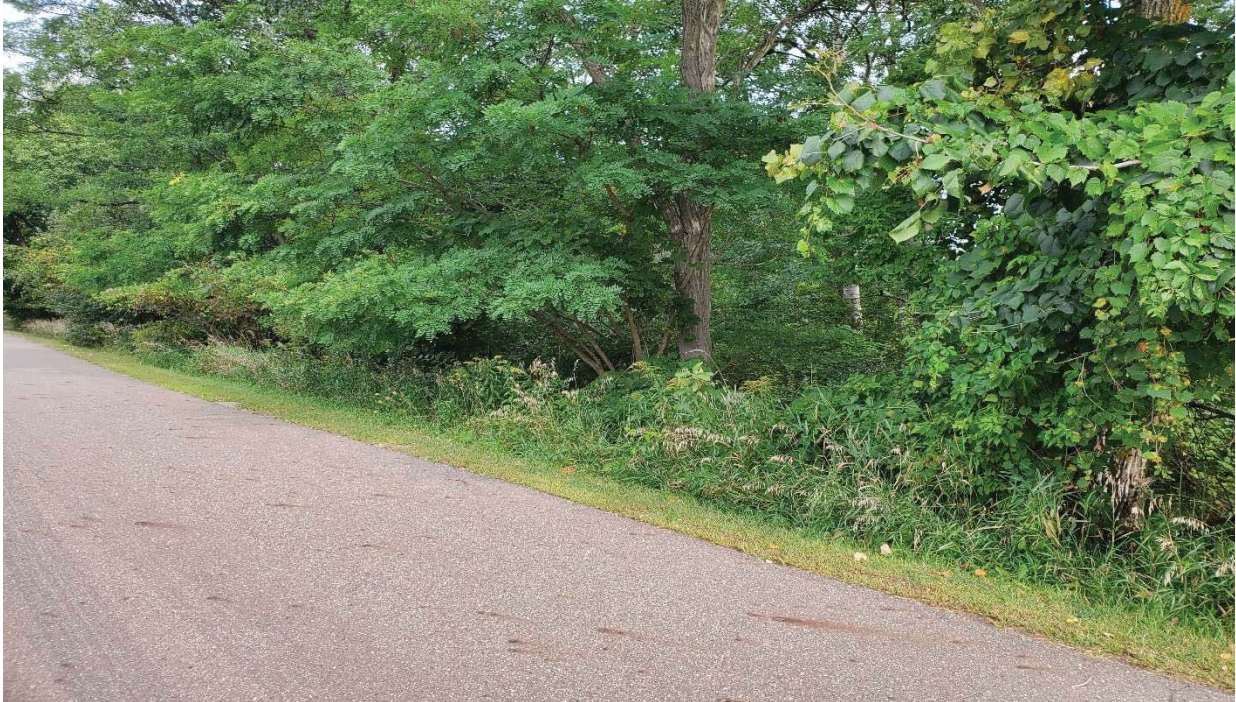
PHOTO 31

NORTH OF ROADWAY EMBANKMENT, WITH TYPICAL TREE AND BRUSH GROWTH THROUGHOUT

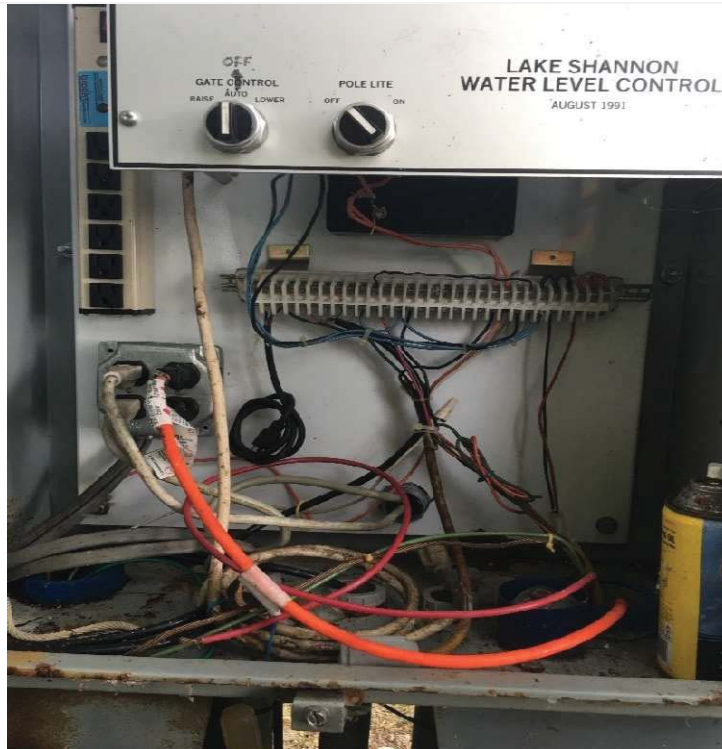
PHOTO 32

WATER LEVEL CONTROL ELECTRICAL BOX OFF DAM CONTROL STRUCTURE

3. The electrical cabinets need to be updated to meet current electrical standards. The use of plug-in extension cords within the cabinets is not in line with electric codes. Section 400.8(1) of the National Electric Code (NEC) does not permit flexible cords and cables to be used as a substitute for permanent wiring of a structure. Currently, the electric box on land has three extension cords plugged into a 4-outlet box. One extension cord extends through the buried conduit to the gate structure. At the gate structure control box, the extension cord is plugged into the electric cord for the power drive unit. The power drive should be plugged directly into a hard-wired outlet box, rated for minimum 15 amps (20 amps preferred).

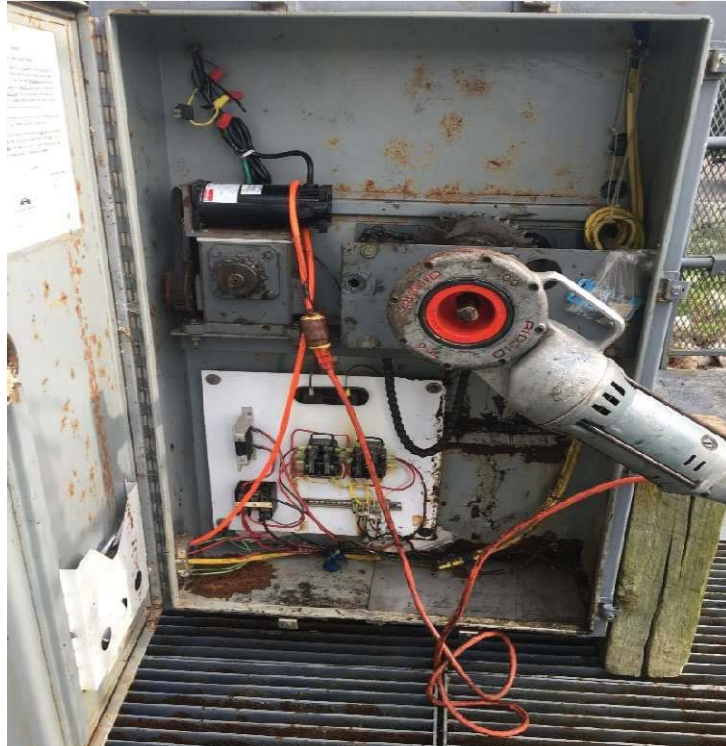
PHOTO 33

WATER LEVEL CONTROL BOX ON DAM CONTROL STRUCTURE
